# **Study of Transportation Accident Severity**

**Marvin Resnikoff**

**Radioactive Waste Management Associates**

**Nevada Nuclear Waste Project Office**

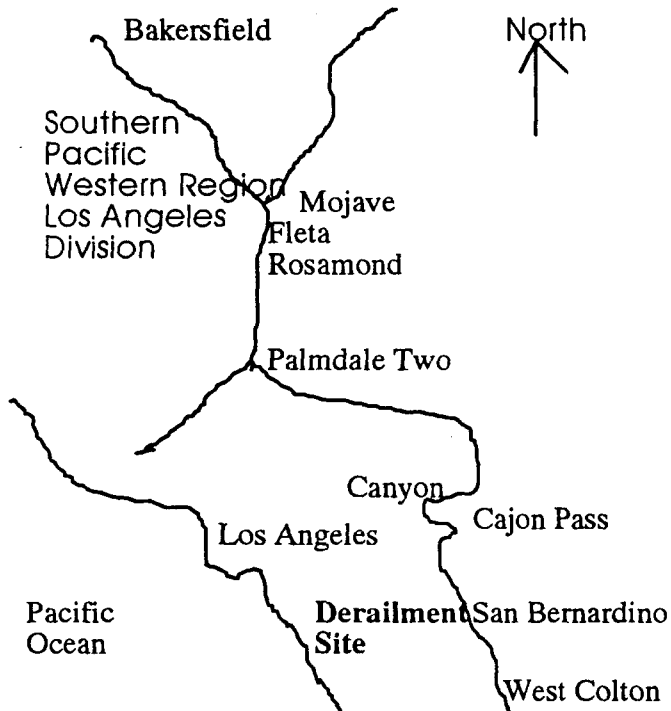
The probable cause of the train derailment was the failure to communicate the status of the dynamic brakes and Southern Pacific's rule that provided inadequate direction to the head end engineer on the allowable speed and brake pipe reduction down the 2.2% grade. Inadequate inspection of the pipeline following derailment that failed to detect severity of the damage due to earth-moving equipment.

Figure. Mojave Subdivision of Southern Pacific. Derailment site is located near San Bernardino.

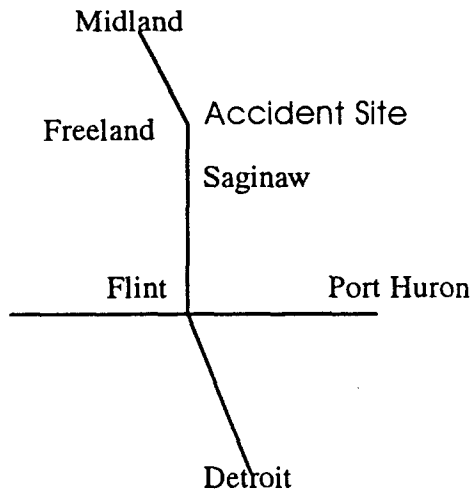
Route of freight train R-331-22.

The probable cause of the accident was inadequate car inspection by CSX and ATSF that resulted in wheel lift and the derailment of ATSF 90005. Large trimethylchlorosilane fire.

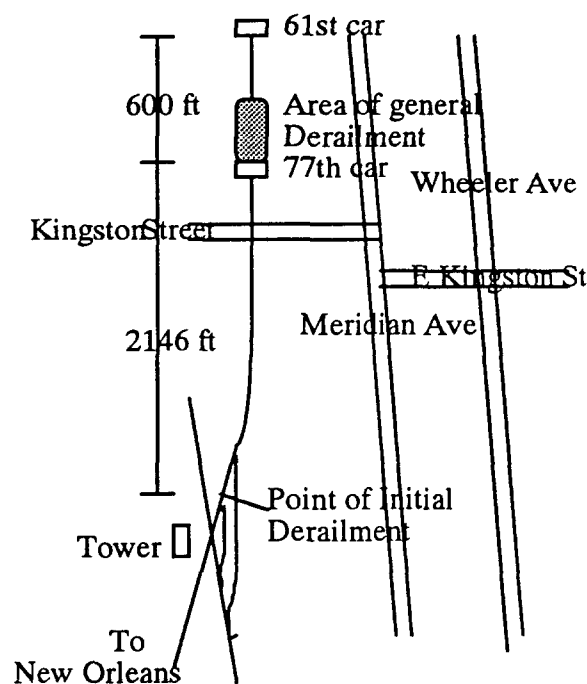
From Dragon, the train had a total tonnage of 10,486 tons (102 loads, 37 empties, caboose), arriving at Laurel at 4:15 am. Speed was about 28 mph. October 1968, the GM&O crossing was completely rebalasted and the crossing surfaced. Immediately after the 1st of 26 tank cars (the 61st car) passed the crossing, the operator heard a loud noise and saw sparks and fire around the front truck of the 62nd car. He went to the tower to notify the dispatcher at Hattiesburg to stop train 154, but before he could do this the derailment occurred. The cause of the derailment was a broken wheel. Substantial tread worn hollow condition. The mating wheel derailed about 256 feet further.

14 of the derailed cars, about 850 feet in length, were piled into a space of about 400 feet in length. The first 61 cars remained on track. The rear 63 cars remained on track, with the 76th car stopping about 20 feet from the derailed cars. Large mushrooms of flaming propane shot hundreds of feet into the air. 19 pieces of tanks were hurled off the right of way. One piece of tank car was hurled into a pumphouse of a city well and cut an 8 inch water main, reducing the pressure. The fires in the residential area were under control by 11 am, 6 1/2 hours after the wreck occurred.

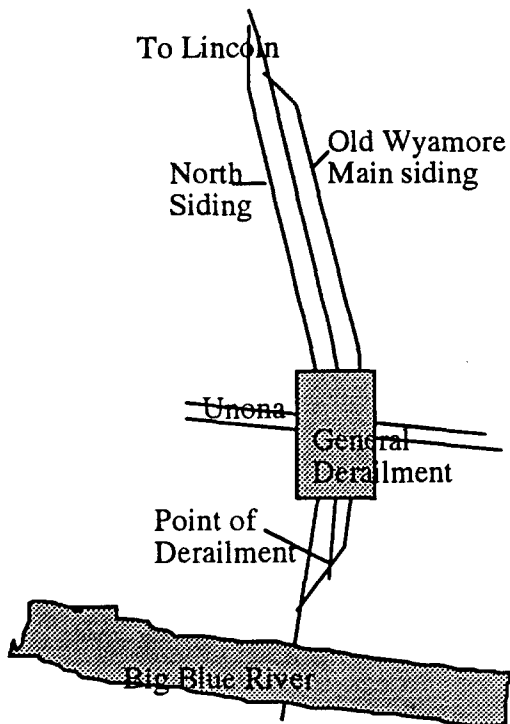
The derailment was due to movement of the rail caused by lateral forces. The cause of the complete failure of the tank car was due to its being struck by the coupler of another car and the brittleness of the tank car steel at 4°F.

The accident occurred at Crete, 20.1 miles west of Lincoln on CB&Q's Lincoln Division which extends from Gaines to Lincoln, 98.4 mi. Other tracks: a single track branch line, the Wymore Branch, connects with the main track at a point 4016 ft west of Crete. At Crete a siding, 3996 ft in length, known as Old Wymore Main, parallels the main track. A siding 4,703 feet also parallels the main track on the north. A bridge over the Blue River is 382 ft in length. West of Crete on the main track, there is a 2° curve to the south for 2106 ft and then straight for 1175 ft over the bridge.

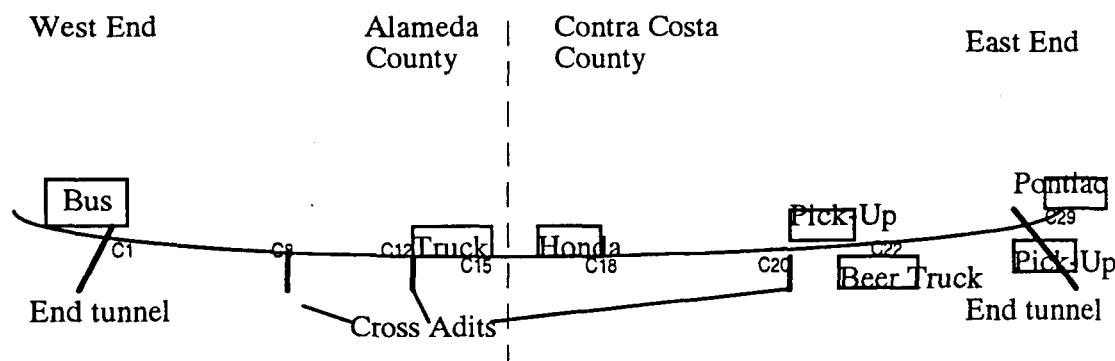
Figure. Plan of California Ste Rte 24 through the Caldecott Tunnel, with final resting position of vehicles. Tunnel is 3371 ft long.

The Honda moved to the left lane of the two-lane roadway, struck the left curb and was redirected into the right lane and then back to the left lane before slowing and coming to a stop adjacent and parallel to the left curb. Two drivers passed the Honda while it was slowing and three others passed it while it was stopped. The Honda's emergency flashers were on.

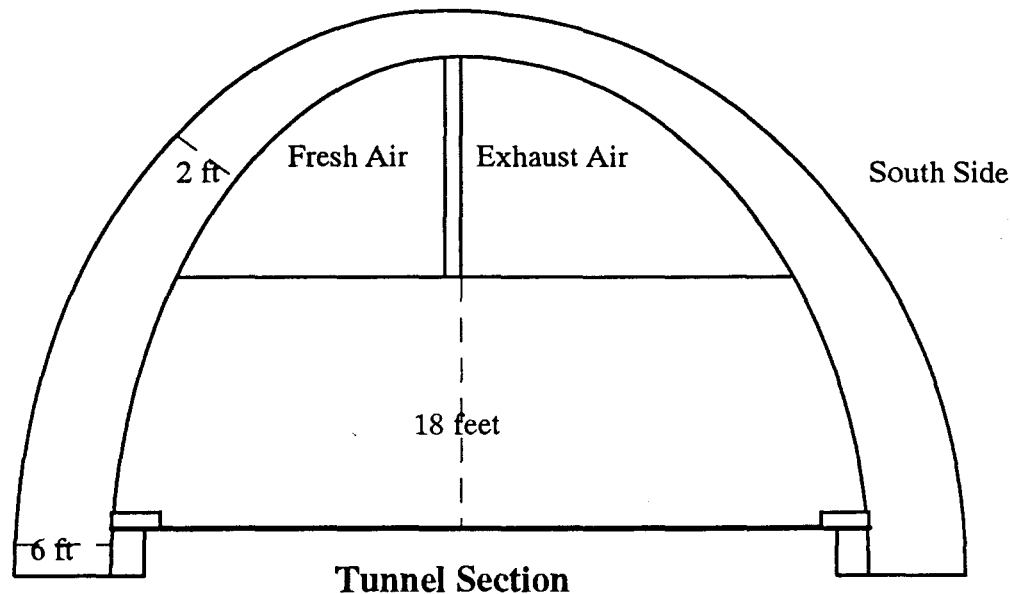
The arched walls of the bore are Portland cement covered with 4.25 inch square green tiles. On each side of the tunnel, at the junction of the curved ceiling and the walls is a continuous longitudinal line of fluorescent lights. Fresh air is taken in at the west portal building and carried through a duct above the roadway. The air is discharged through 1ft by 5 ft openings spaced at 15 ft intervals at one side of the ceiling and is drawn out through exhaust portals on the opposite side of the ceiling. For each duct there are two fresh air blowers and two exhaust blowers that have a total capacity of 0.5 million cubic feet per minute.
